# NONPOINT SOURCE PROGRAM SUCCESS STORY

### Pasture Grazing Best Management Practices Result in Pathogen (Fecal Coliform) Delisting

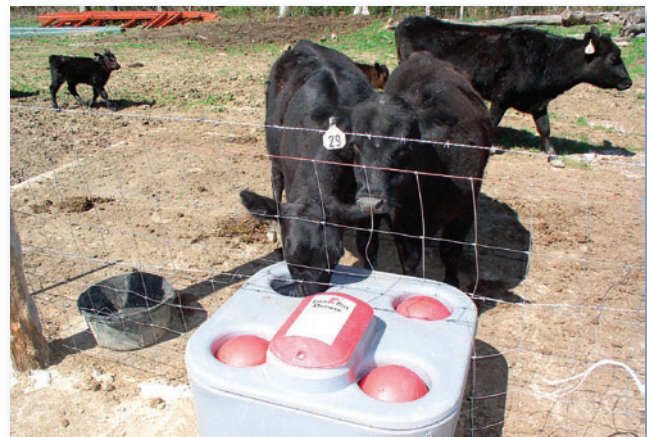
Exclusion fencing was installed to limit cattle's access to creeks, and alternative watering sources were constructed at eight different locations.

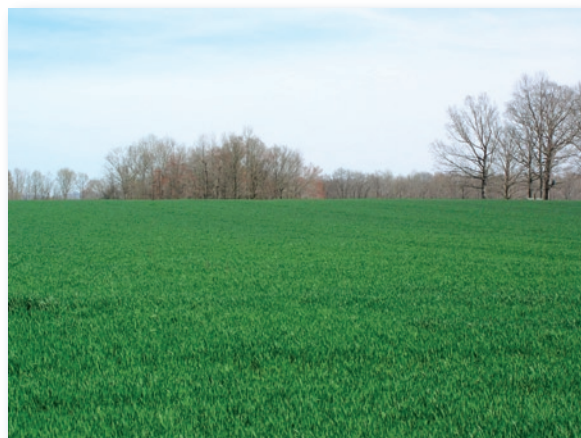
Sediment loading in the watershed was reduced by implementing conservation tillage and planting cover crops on approximately 2,000 acres.

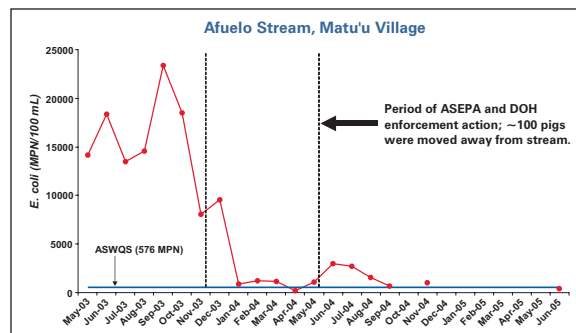
Weekly stream samples reflect declining instream *E. coli* levels following a collaborative educational and enforcement effort by the American Samoa EPA and the American Samoa Department of Health. American Samoa water quality standards call for a single-sample most probable number (MPN) criterion of 576 per 100 mL.

The beneficial effects of the BMPs on water quality have been dramatic. Average *E. coli* concentrations in the stream declined 91 percent (see figure), with preliminary data indicating the stream is now meeting water quality standards. Public awareness of water quality problems and the health threat from leptospirosis has driven community and political will to improve pig waste management throughout the territory.

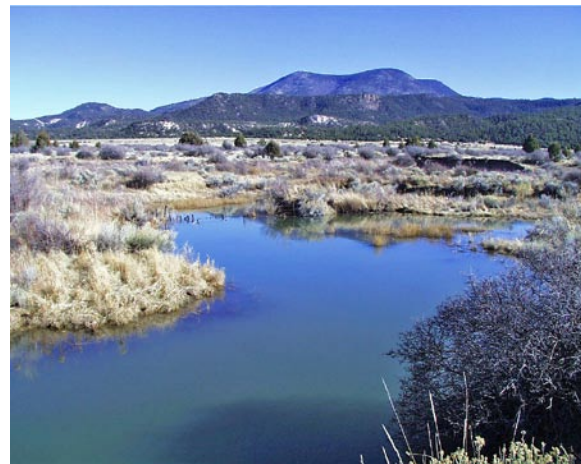
Newly restored Nutriosos Creek now has a higher water table, less erosion, and more wildlife species.

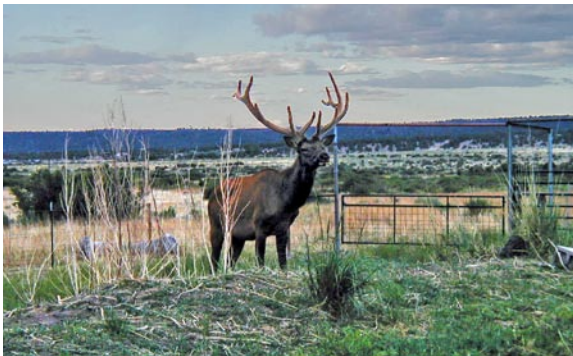
Crosswhite used fences to eliminate or control wildlife and livestock activities in the riparian areas.

he implemented BMPs: (1) he fenced out elk entirely and limited livestock grazing to the dormant winter months; (2) he planted willow poles and installed practices such as weirs to reduce streambank erosion; and (3) he established native narrow-leaf cottonwoods and Western Wheatgrass. Crosswhite's second step was to adopt livestock (cattle), nutrient, irrigation water, and pest management plans recommended by the Natural Resources Conservation Service (NRCS). As his final step,

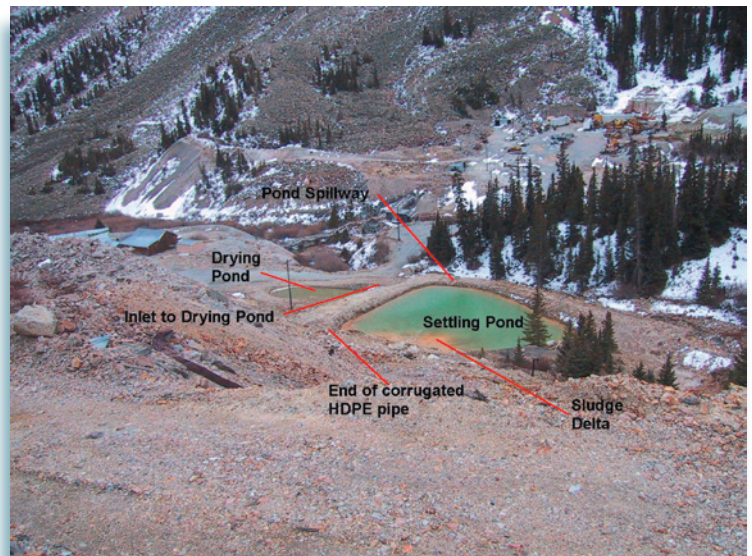
The mine drainage treatment system mixes kiln dust with acidic runoff to increase the pH of the drainage water. Once a pH of between 9.5 and 10 is achieved, metals are precipitated out in a settling pond and the clean water is returned to the creek.

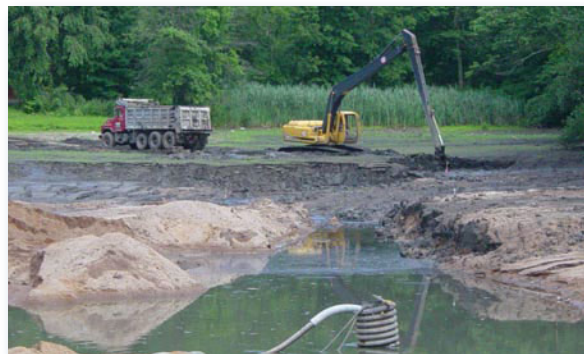
Decades of organic matter accumulation reduced average pond depth to 2.5 feet, with some areas as shallow as 1.5 feet. Dredging restored the pond to a maximum depth of 10 feet.

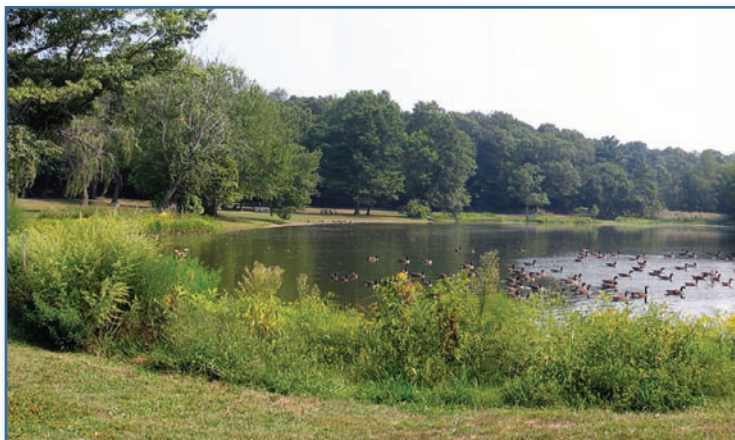
One view of Edgewood Park Pond after restoration. Littoral plantings and a stabilized bank are shown to the center and left.

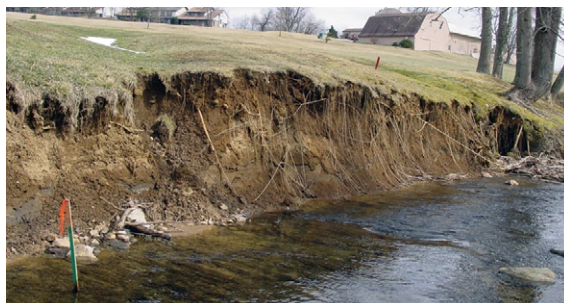
Figure 1. Pre-restoration: Severe bank erosion along the Pike Creek mainstem at the Three Little Bakers Golf Course. (Source: DNREC 2002)

A Riparian Corridor Stream Inventory Study conducted by the DNREC's Whole Basin Piedmont Team in 1998–1999, and a Christina River Watershed Restoration Study conducted in 1999 identified the upper Pike Creek as a segment in need of restoration. The studies showed that the stream had significant bank erosion, which contributed to heavy sediment loads and degraded aquatic habitat. Deep entrenchment with nearly vertical eroding banks was evident in several segments, and numerous mid-channel bars had formed from the heavy sedimentation (Figure 1).

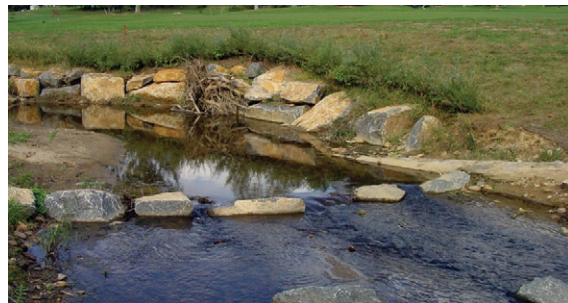
Figure 2. Post-restoration: Rock toe and vane, cross vane, and rootwad installed for bank stabilization, hydrologic direction, and grade control. (Source: DNREC 2005)

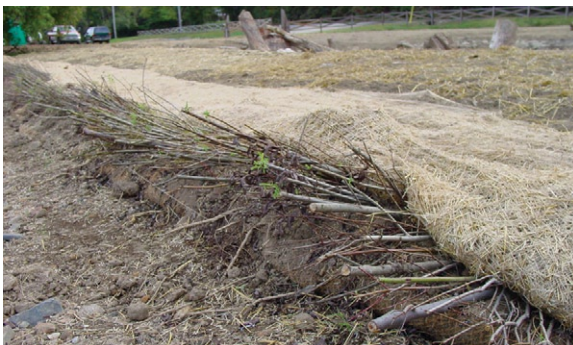
Figure 3. Post-restoration: Live riparian willow sprigs (*Salix* sp.) and coir matting installed for bank stabilization and to establish a riparian buffer. (Source: DNREC 2005)

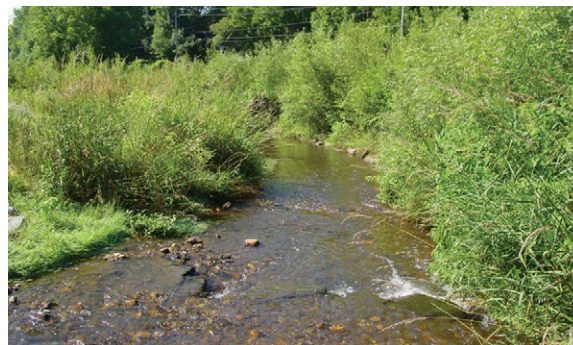
Figure 4. Post-restoration: Willow plantings one year after restoration (same area pictured in Fig. 3). (Source: J. Meyer 2006)

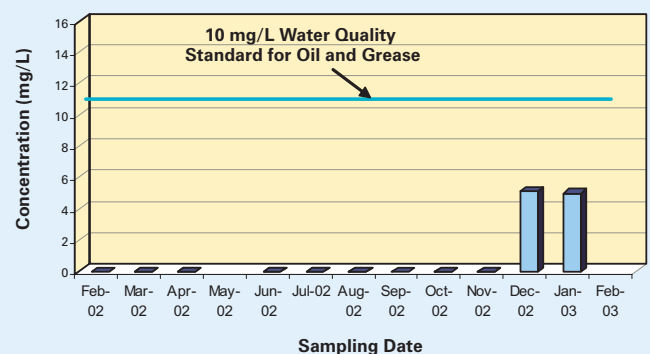
Hickey Run Oil and Grease WQS Attainment Data

These graphs illustrate an 88 percent reduction in oil and grease that has led to the removal of Hickey Run from the 303(d) list of impaired waters.

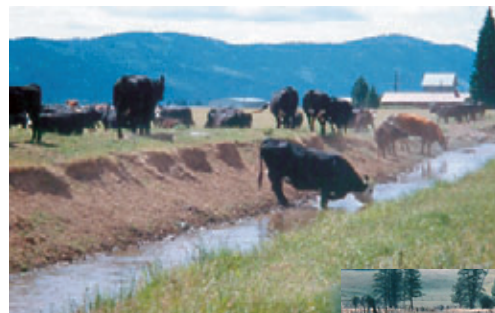
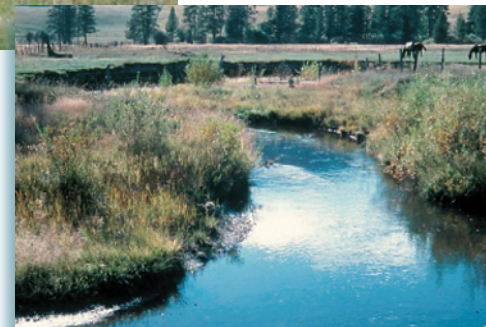
*Before:* Drain ditch leading to Cascade Reservoir prior to installation of BMPs.

*After:* Drain ditch after cattle have been removed from the ditch area and vegetation reestablished.

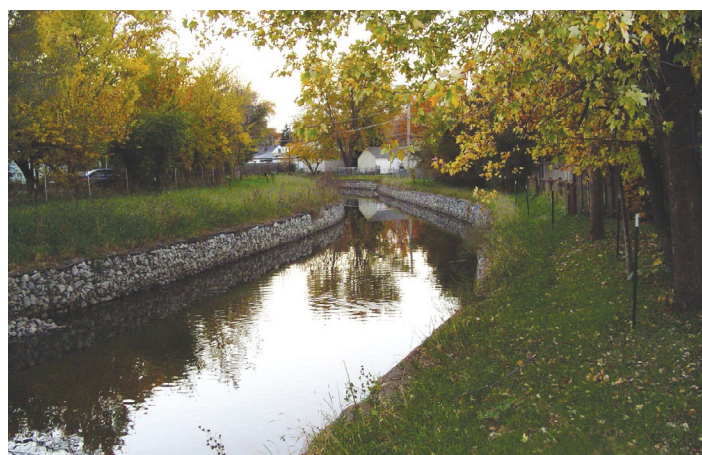
Figure 2. A gabion toe (cage filled with earth and rocks) protects the left and right banks in this section of Addison Creek.

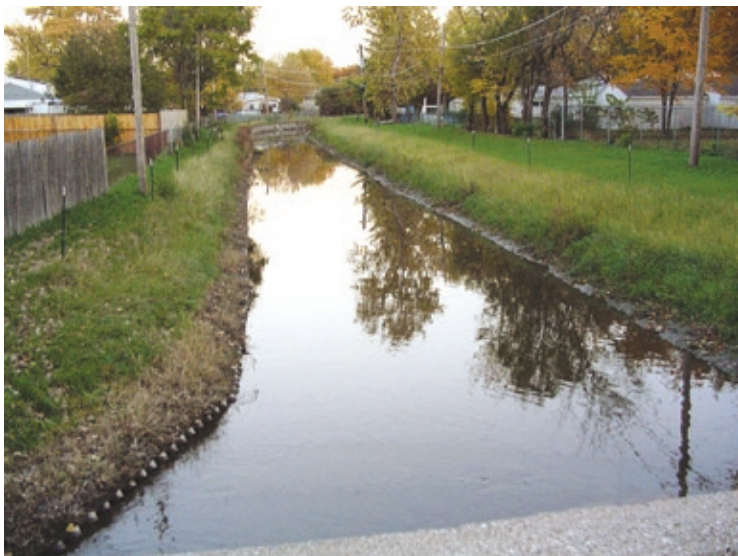
Figure 3. Streambank stabilization techniques used on this portion of the creek include vegetated banks with an A-Jacks toe on the left bank and a Stabulator toe on the right bank.

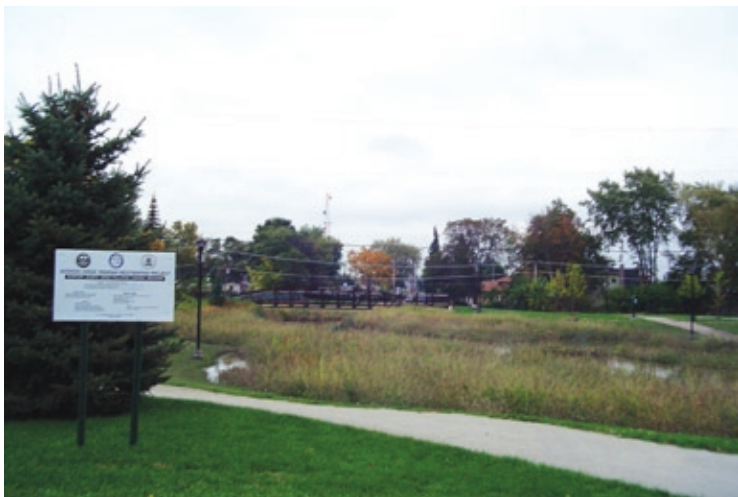
Figure 4. Along this section of the creek, the partners restored a streamside wetland and stabilized the streambank with vegetation, riprap, and riffles.

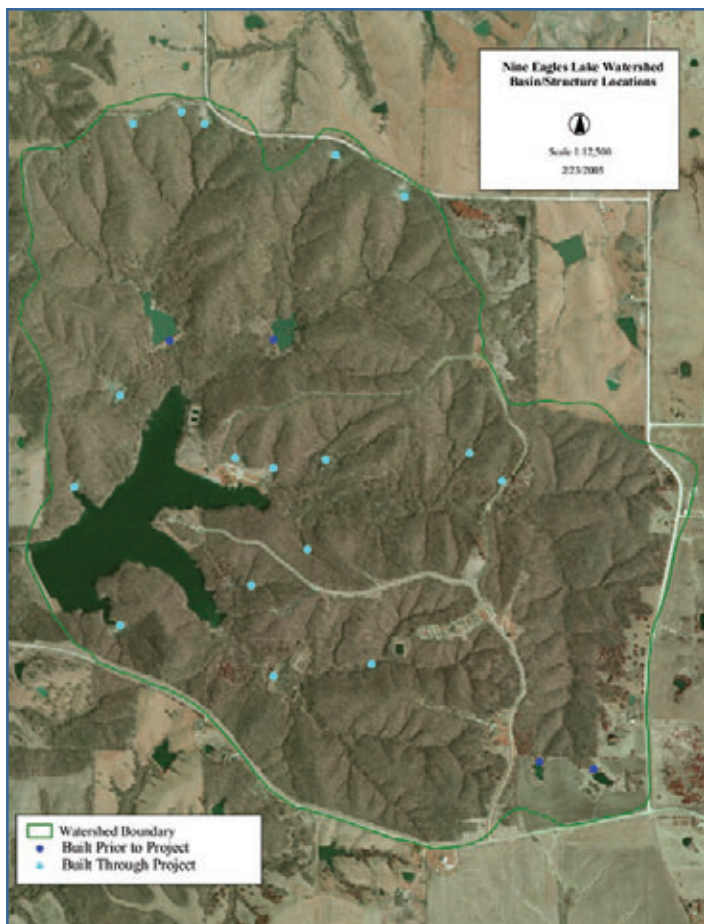
Seventeen new sediment basins were constructed using section 319 funds.

To accomplish these goals, IDNR developed an implementation plan for Nine Eagles Lake focusing on reducing sediment delivery in the watershed. Section 319 grant funds were used to construct 17 sediment basins. In 2003 the IDNR Parks Bureau rerouted and reworked some of the trails to reduce impacts. Throughout the project, care was taken to protect the forested areas, home to the endangered Indiana bat.

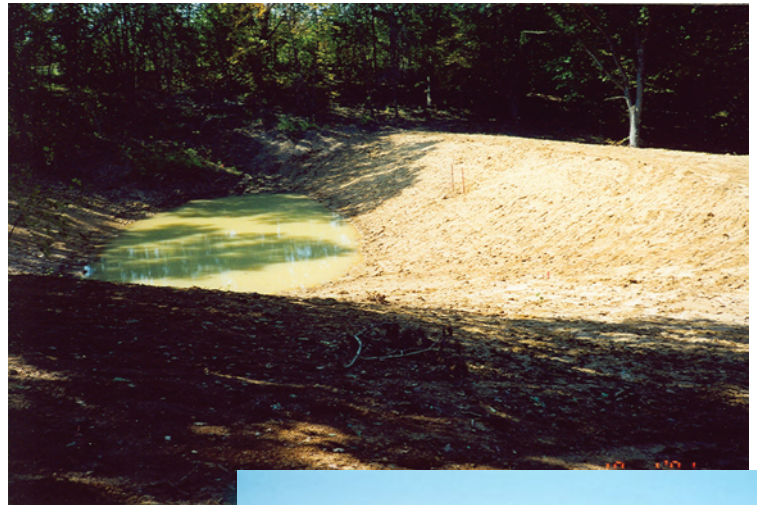
Sediment basins prevent excess sediment from reaching the lake by collecting runoff water and allowing sediment to settle out of the water and be deposited in the sediment basin.

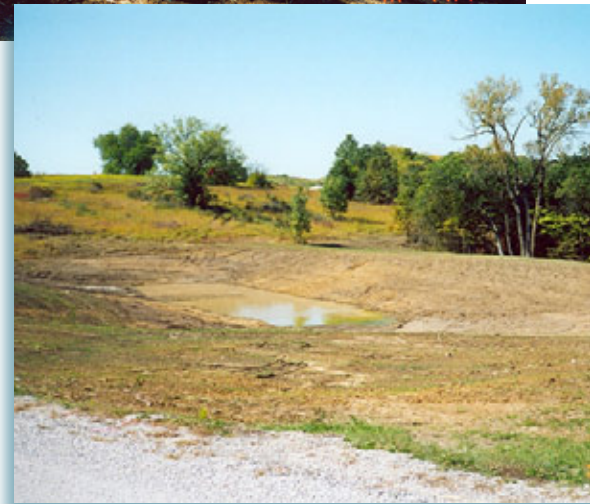
Sediment control structures were constructed throughout the watershed to reduce sediment delivery to the lake.

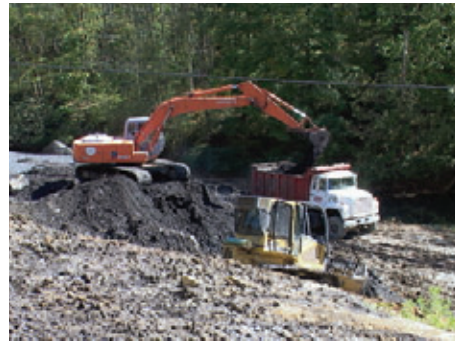
Bank restoration along Rock Creek has reduced sediment loading by 500 tons per year.

Fork of the Cumberland River from Rock Creek has decreased from a monthly average of 110 metric tons to near zero. Removing 25,000 cubic yards of coal refuse from streamside areas and revegetating the banks of Rock Creek have reduced the sediment entering the stream by 500 tons annually. Fish populations are improving in the lower Rock Creek watershed, and the number and diversity of fish species are increasing. Stations that once supported no fish are now supporting fish. Because of these improvements, Rock Creek has been reclassified from full nonsupport to partial support for aquatic life and swimming on the 2002 Kentucky 303(d) list.

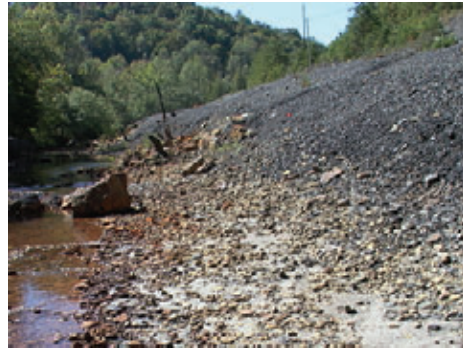
Rock Creek bank before restoration.

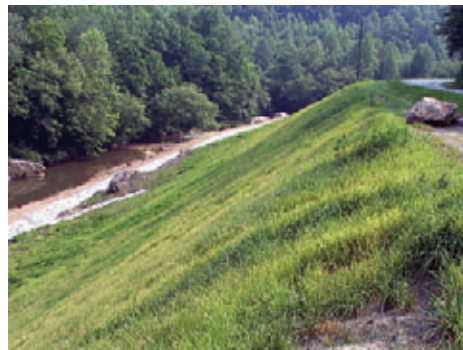
Rock Creek bank after restoration.

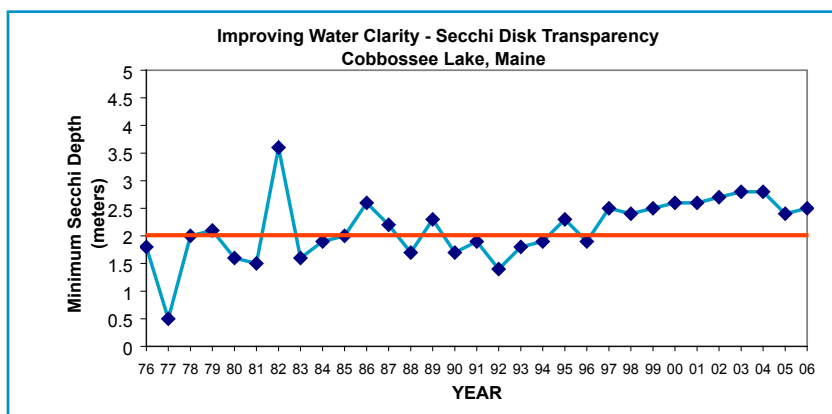
Minimum Secchi Depth readings (1976–2006) indicate no nuisance algal blooms have occurred since 1997. Maine's definition of a nuisance algae bloom is a minimum Secchi Disk Transparency of less than 2.0 meters in lakes.

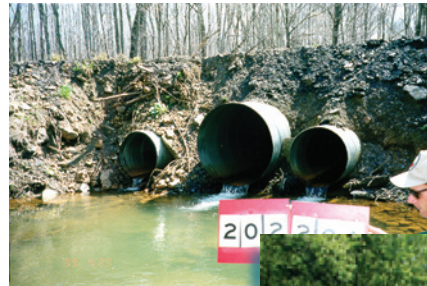
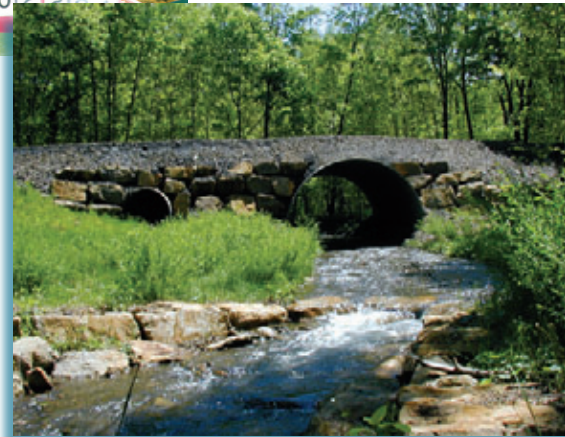
Photos of the culvert/fish blockage taken before and after the Neff Run Phase I project show significant improvement. (Photographs courtesy of Maryland DNR's Watershed Services Center)

Phase I called for the removal of a major fish blockage and installation of rock cross vanes and j-hooks (both consist of rock structures placed across the stream channel) to reduce stream erosion. Also, approximately 4,000 feet of fence and stream bank protection was installed to stabilize the stream. The Phase I

Phase II of the project included the removal of an additional fish blockage that prevented the migration of fish upstream. To eliminate the blockage, 16 rock cross vanes were installed downstream to stabilize the channel and elevate the streambed. The Allegany Soil Conservation District assisted with the restoration of an additional 1,000 feet of streambank and stream channel.

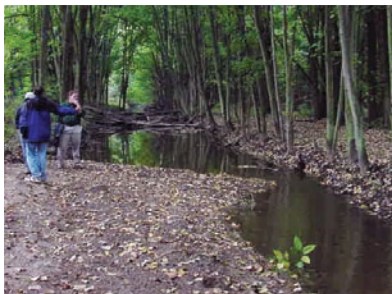
Figure 1. Before: Note the shallow, linear stream channel and the lack of in-stream habitat features.

MIDEQ determined that the quality of the biota in this segment of the creek was reduced by urban runoff, poor in-stream habitat, and excessive sediment deposition (Figures 1 and 2). MIDEQ completed a Total Maximum Daily Load (TMDL) for Carrier Creek biota in 2002. As noted in the TMDL, achievement of the WQS for designated uses for Carrier Creek will be demonstrated by assessing the macroinvertebrate community and the in-stream habitat as it relates to sediment.

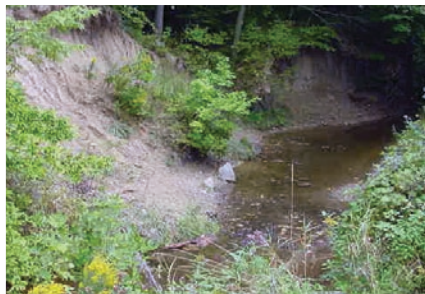
Figure 2. Before: Note the erosion of historic dredge spoils and poor in-stream habitat.

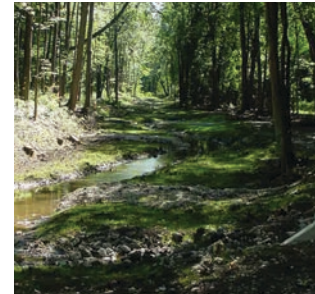
Figure 3. After: Restored stream meanders.

In 2000 a team of contractors, local agencies, and volunteers stabilized and restored 5 miles (3,771 linear feet) of channel using funding from MIDEQ. These projects increased channel stability, improved in-stream habitat, and reconnected the channel to its floodplain. The upstream end of the channel was narrowed, and the stream pattern was reestablished with structures that promote meandering. Throughout the rest of the restored reach, various structures were installed to stabilize the channel, including cross-vanes, J-hooks, lunkers, log revetments and riprap (Figures 3, 4, and 5). In some locations, the project team removed dredge spoils that were separating the stream from its natural floodplain.

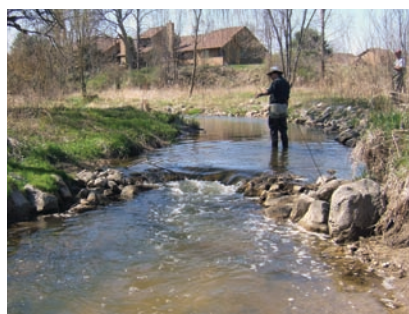
Figure 4. After: A crossvane.

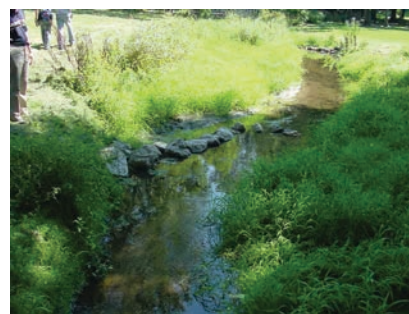
Figure 5. After: A J-Hook.

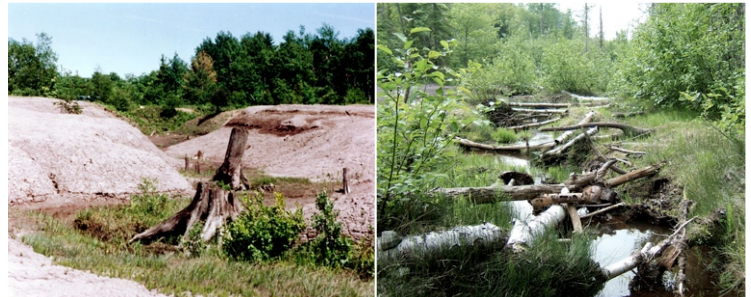
**Figure 1. Kearsarge Creek before and after restoration.**

Before: Stamp sand deposits cover streambanks and riparian area.

After: Removal of upstream stamp sand source allows revegetation of streambanks and riparian area.

stabilized one 2.5-acre deposit in the Kearsarge Creek watershed in 1998 (Figure 1). U.S. EPA stabilized another 19-acre deposit along Scales Creek in 2005 using Superfund Program funds (Figure 2).

The Kearsarge Creek project stabilized a 2.5-acre stamp sand deposit and triggered natural revegetation downstream. This improved the in-stream habitat conditions and benthic macroinvertebrate communities. In-stream copper concentrations fell by a factor of 10, total macroinvertebrate taxa tripled, sensitive macroinvertebrate taxa (mayflies, caddisflies, and stoneflies, also known as EPT) returned, and the in-stream habitat assessment noted steadily less sediment deposition between 1991, 2001, and 2006 (Table 1). Michigan Department of Environmental Quality (MIDEQ) uses a macroinvertebrate community scoring procedure to identify impaired waterbodies. Possible scores range from -9 to +9; a score of less than -4 is considered unacceptable. Macroinvertebrate scores improved from a score of -7 in 1991 to +2 and +1 in 2001 and 2006, respectively.

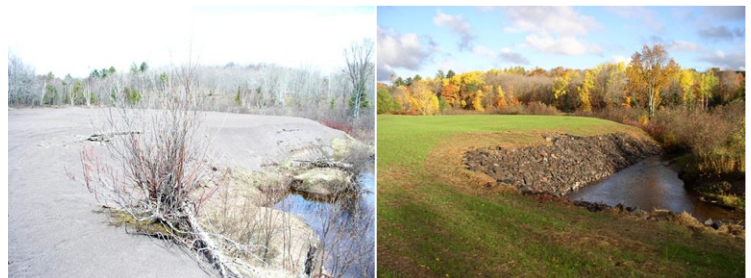
**Figure 2. Scales Creek before and after restoration.**

Before: Stamp sand deposits cover streambanks and riparian area.

After: Habitat improves once stamp sand source is removed and streambanks and riparian area are stabilized.

feet of Scales Creek streambank. MIDEQ noted measurable improvements within one year of this project's completion; between 1991 and 2006 in-stream copper concentrations decreased slightly, total macroinvertebrate taxa increased by 40 percent, sensitive macroinvertebrate taxa doubled, and in-stream habitat features such as substrate embeddedness and sediment deposition improved substantially (Table 2). Macroinvertebrate scores, as determined by MIDEQ's scoring procedure, improved from 0 in 1991 to +4 in 2006. MIDEQ expects scores to continue to improve as biota colonizes the improved habitat. Given the positive results from both projects, MIDEQ expects to remove Kearsarge Creek/Scales Creek from the state's 303(d) list by 2008. MIDEQ will survey the creeks again in 2011.

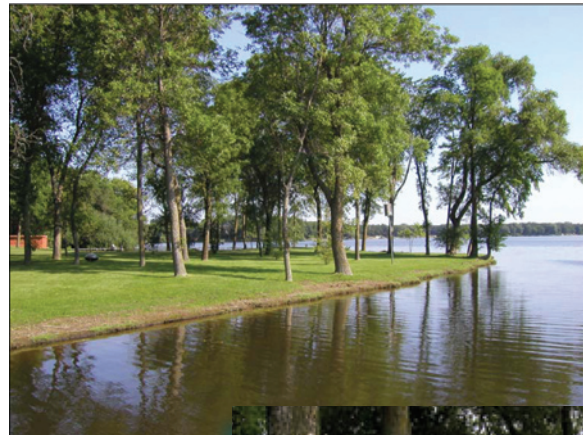
Vegetative filter strips, installed along shorelines (lower picture), help reduce nutrient transport to the lakes.

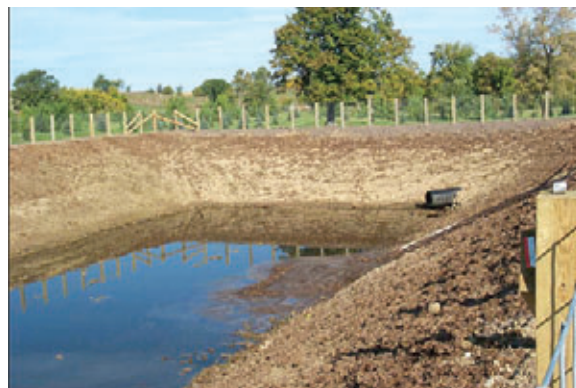
Waste storage facilities at livestock operations help reduce nutrient runoff to the lakes. Project partners installed and improved 50 storage facilities.

The Sauk River Chain of Lakes Watershed Management Project was initiated in 1997 to maintain and improve water quality by reducing the impacts of nonpoint source pollution. To reduce erosion and phosphorus runoff from agricultural areas, the project partners installed and improved 50 agricultural waste storage facilities, generated more than 40 Manure Management Plans, installed feedlot filter strips and retention basins, and enrolled more than 5,000 acres into the U.S. Department of Agriculture (USDA) Farm Service Agency (FSA) Conservation Reserve Program. Vegetative buffer strips were planted and shoreline areas were restored to prevent erosion along riparian

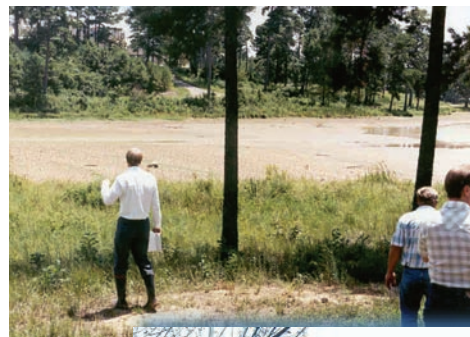
Lake Hazle before the restoration project, almost completely filled in with silt.

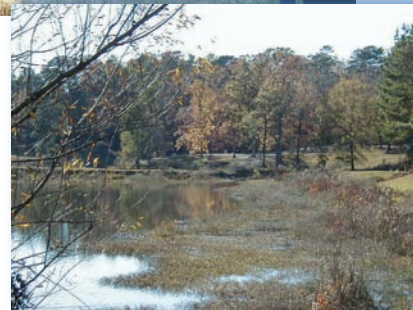
Lake Hazle as it appears today, supporting aquatic life.

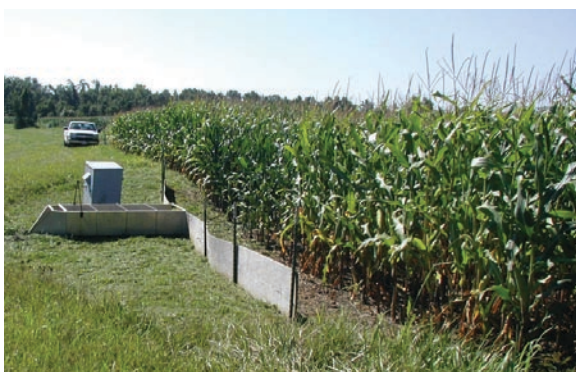
Edge-of-field runoff monitoring equipment

Approximately 50 automatic monitoring samplers were placed at field edges and in large and small streams that flowed into the lakes. Strategically sited monitoring stations measured the relative contribution of smaller subwatersheds into the lakes. Stream flow was taken into account at each sampling location. Each station had instrumentation that allowed simultaneous sampling and flow measurements during peak rainstorm flow events. The lakes themselves were sampled in late March (before seasonal atrazine applications) and continued every 3 weeks until September. The

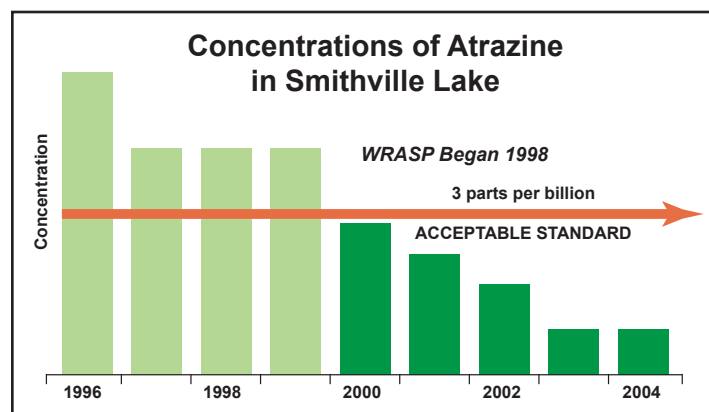
Collaboration under the WRASP project led to reduced concentrations of herbicide in Smithville Lake.

Levels of atrazine (and other contaminants in the lakes) began to decrease after the first year of the project. The lakes' average levels of atrazine dropped below the MCL of 3 ppb for drinking water, and the Missouri Department of Natural Resources removed the lakes from the 303(d) list in late 2003.

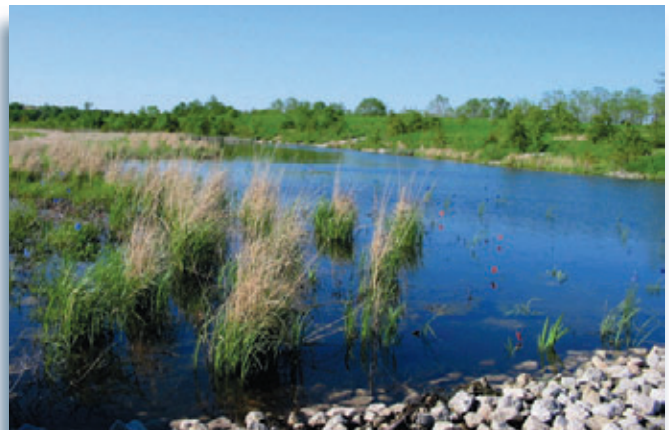
Acidity, sulfates, and metals are removed from AMD as it flows through layers of limestone rock and compost in the passive treatment wetland cells.

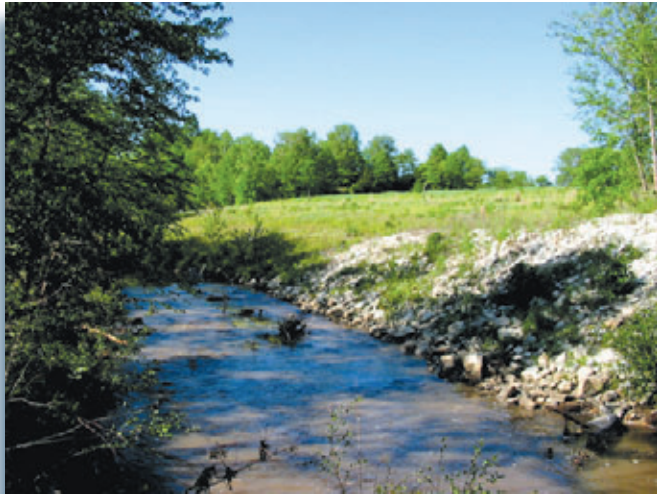
Native trees and grasses are thriving along sections of restored streambank.

neutralized. Streambank restoration projects further added to the health and renewal of the creek. Project partners planted approximately 200,000 native trees and shrubs and helped repair 2,700 linear feet of eroding streambank at 16 restoration sites. Sixty-six acres were amended and seeded with native grasses for erosion control and wildlife habitat enhancement. Additional native grass plantings are planned for the coming years.

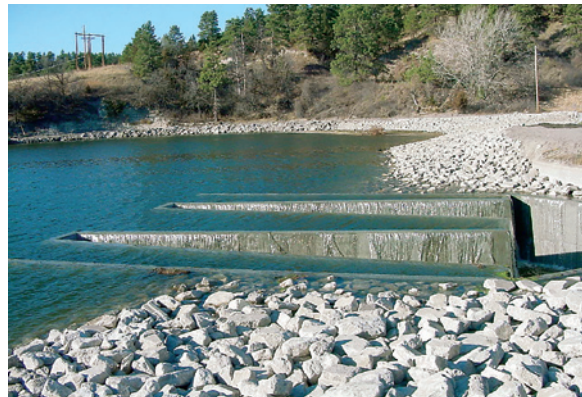
As part of the project, a unique labyrinth spillway was constructed to pass large storm event flows without manual operation. The hydrosuction system passes around the dam shown here.

Mechanical dredging was necessary to remove sediment deposits and deepen the lake, but that alone would not solve the excessive sedimentation problems. To prevent excessive sedimentation from reoccurring, an innovative solution was needed. Rollin Hotchkiss, Ph.D., director of the Albrook Hydraulics Lab at Washington State University, joined the project team as a special consultant to Olsson Environmental Services. Dr. Hotchkiss, formerly with the University of Nebraska, had conducted research involving sediment bypass systems. To address the unique problems of Valentine Mill Pond, he designed a "hydrosuction

sediment removal system" with a unique labyrinth spillway.

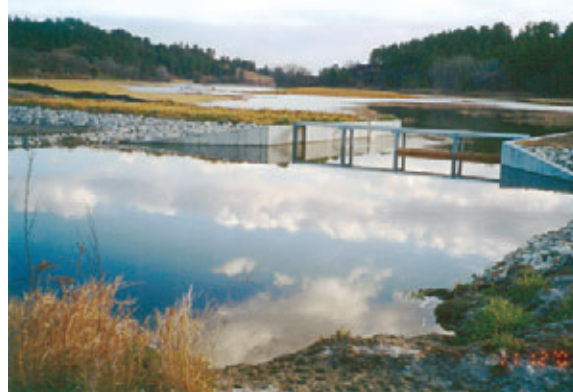
The hydro suction sediment removal system lies directly beneath the walkbridge shown here.

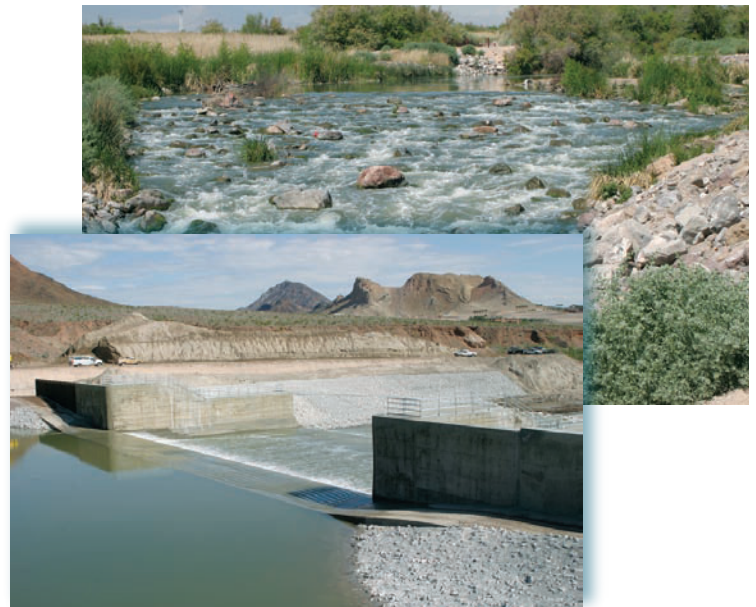
Weirs are low dams designed to reduce streambed erosion by flattening the slope of the channel and slowing flows. Many weirs are constructed of confined rock riprap, providing a somewhat natural look (top). Other structures are built with concrete, resulting in a more engineered look (bottom). Weirs, wetland restoration, and invasive vegetation removal helped reduce TSS concentrations in lower Las Vegas Wash and led to its removal from the Nevada 303(d) list in 2004.

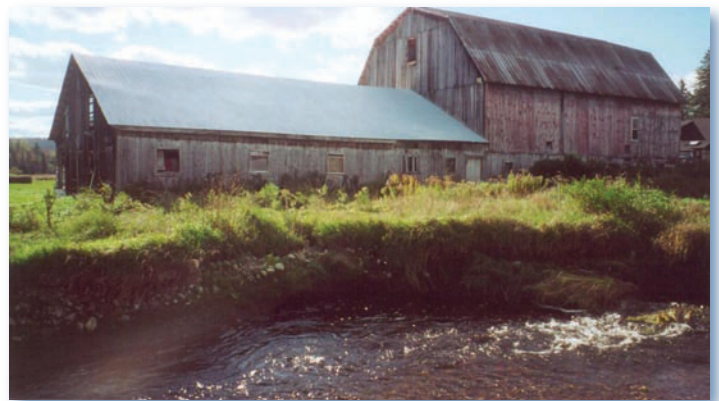
Bog Brook before restoration. Removing riparian vegetation facilitated channel erosion, which ultimately threatened the barn.

Analysis of aerial photographs showed that the stream channel had eroded laterally up to 35 feet between 1999 and 2003, consuming 4,000-square feet of land. This translated to 120 tons of sediment—approximately the amount needed to fill 9 dump trucks—entering the stream each year to worsen water quality and smother fish habitat. Had this been allowed to continue, the stream likely would have cut a new channel into valuable farmland, sending several thousand tons of additional sediment downstream.

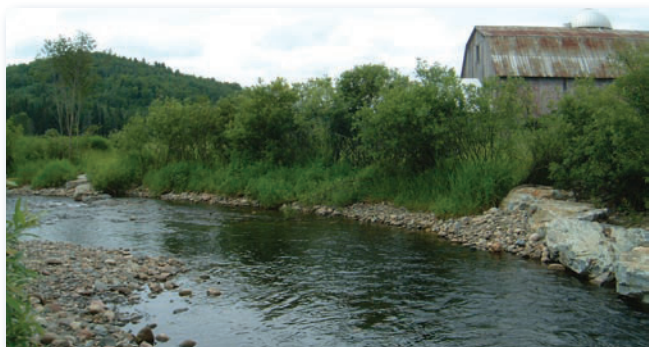
Bog Brook after restoration. The project saved the barn and stopped several thousand tons of sediment from smothering fish habitat.

The partners developed the project using natural stream channel design methods. In the past, landowners and engineers typically turned to hard bank armoring for streambank erosion problems. Because armoring treats only a symptom rather than the cause of bank

erosion, it is often ineffective over the long term. Natural stream channel design uses a stable reference stream to determine the proper slope, width, depth, and geometry needed to restore the impaired stream. To restore channel stability in Bog Brook, project leaders determined it necessary to

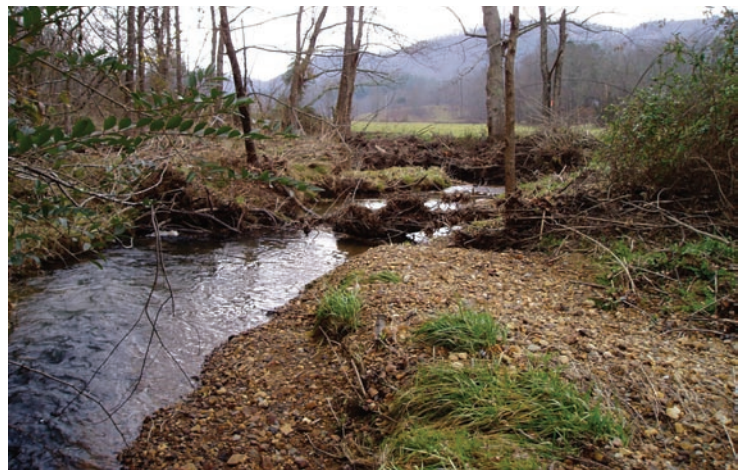
**Before:** Channel instability and bank erosion along this Brasstown Creek tributary were caused by historic channelization, lack of riparian vegetation, and cattle access.

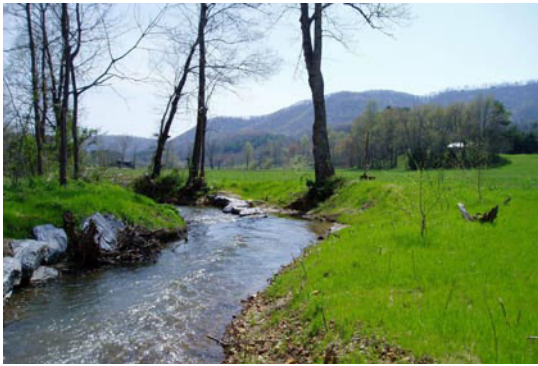
**After:** The rebuilt channel was designed with a more stable pattern, modeled after a similar, relatively undisturbed stream.

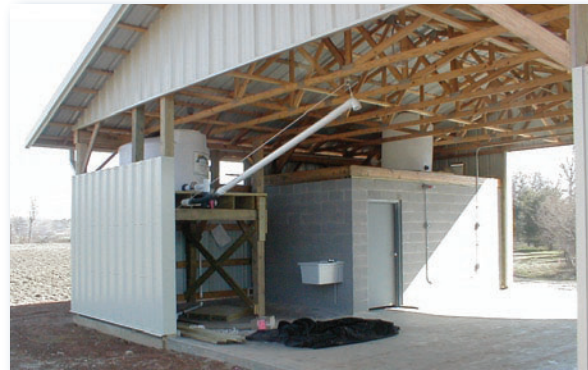
This chemical-handling facility replaced one that was directly adjacent to Mills River.

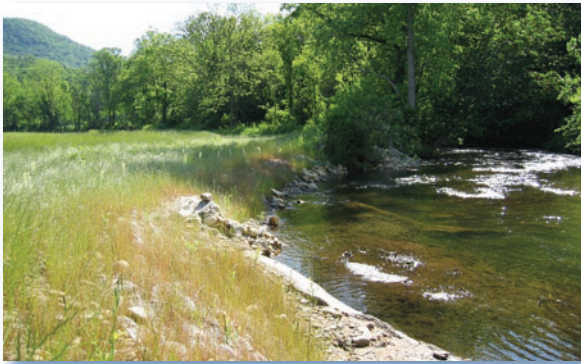
Streambank and buffer restoration shortly after tree planting. Small trees are in the tall grass on the left.

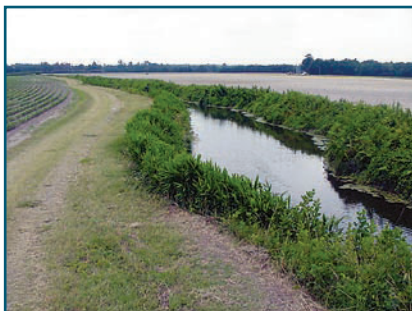
Filter strips in the Neuse River Basin decrease nitrogen loads to the river.

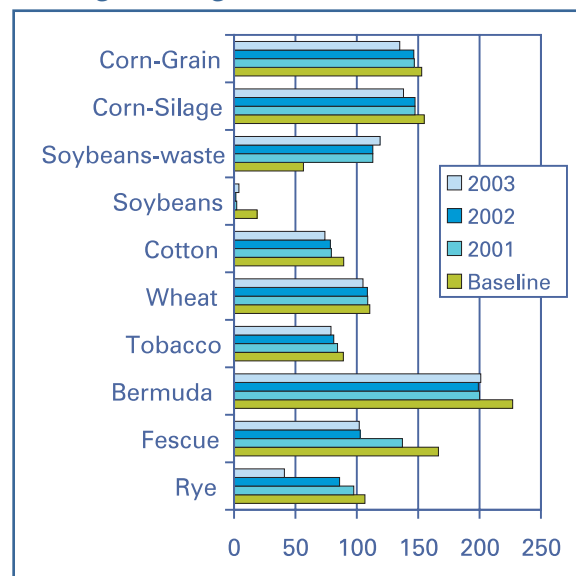
#### Average Nitrogen Fertilization Rates

Decreased fertilizer use was one factor that led to a reduction in nitrogen levels.

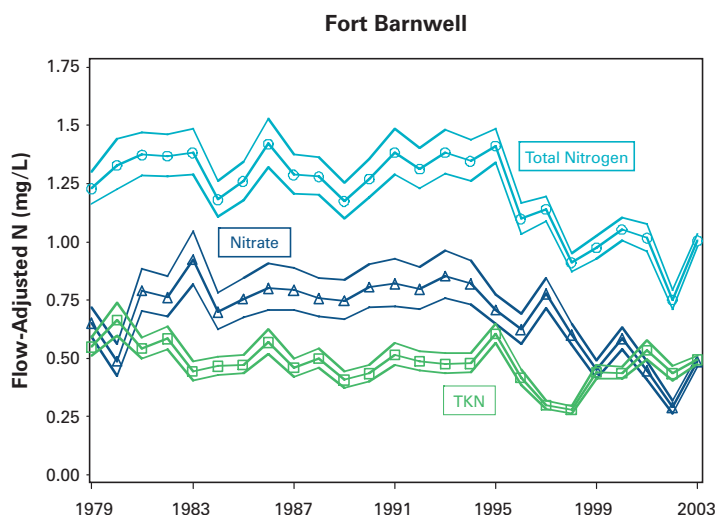
Flow-adjusted total nitrogen concentrations at Fort Barnwell on the Neuse River from 1979 to 2003 showing a 27% decrease in concentration from 1991-1995 base period to 2003. *Dr. Craig A. Stow, University of South Carolina, 2004.*

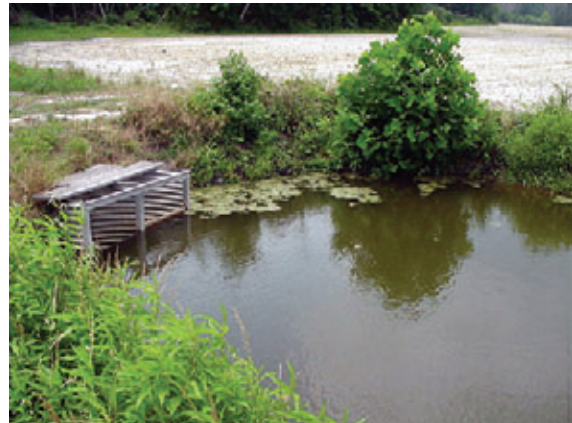
Area farmers installed water table control structures like the one shown here to address excess nutrients.

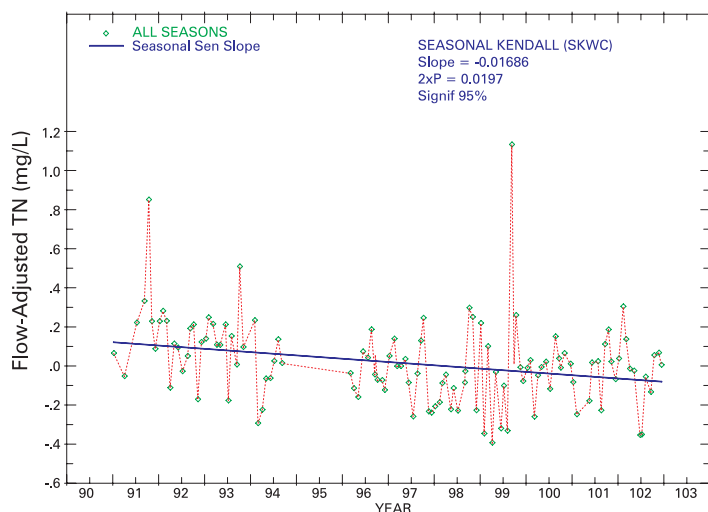
### Sampling at Pamlico Estuary

Samples reflect an 18 percent in-stream reduction in nitrogen.

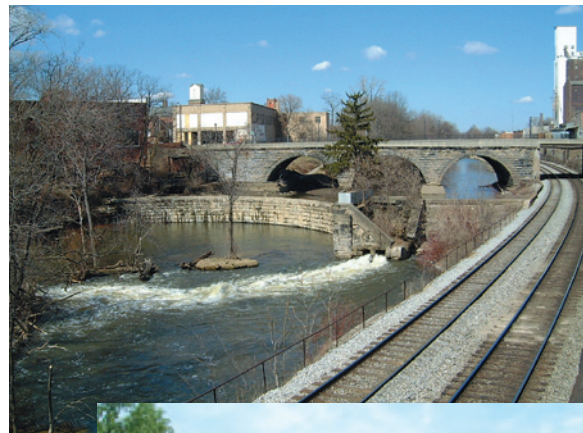
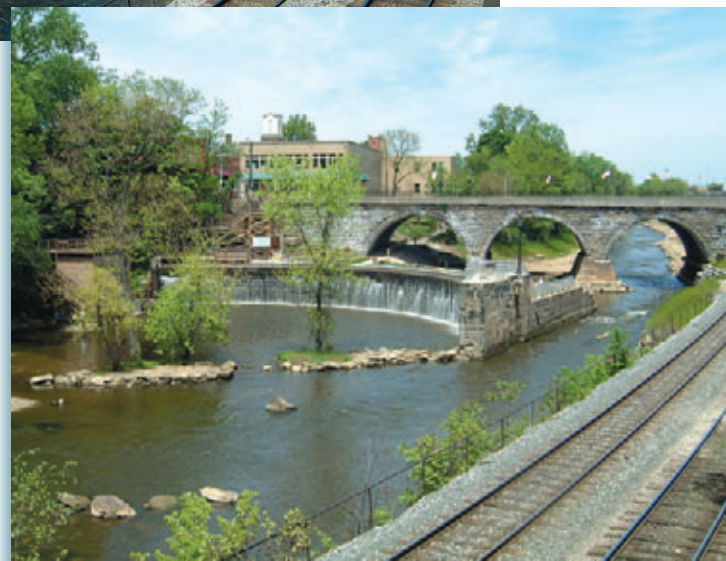
The dam pool was eliminated by removing an old canal lock and allowing the river to return to free-flowing conditions.

Ohio EPA determined that the Kent Dam was contributing to water quality problems due to stagnant flows and eutrophication within the dam pool, causing dissolved oxygen levels to fall well below water quality criteria during periods of low flow. The dam pool altered aquatic habitat, impairing both the health and diversity of indigenous fish species. Additionally, the dam posed a physical barrier to fish migration.

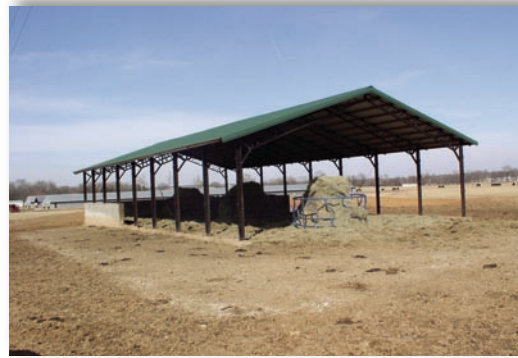
Areas for cattle feeding and waste storage were constructed to reduce the amount of bacteria and nutrients entering the stream.

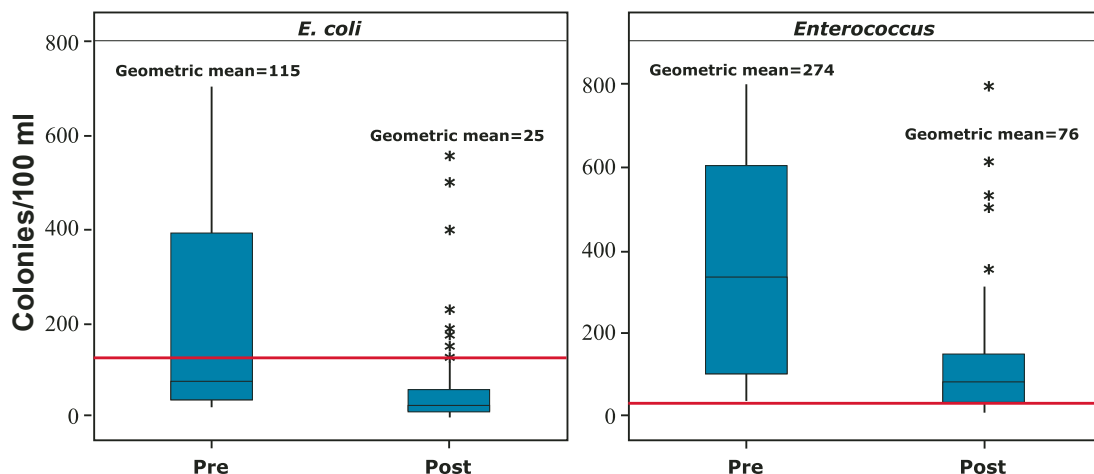
Boxplots indicate the interquartile range (25<sup>th</sup>–75<sup>th</sup> percentile) and median of the data in each of two periods: “Pre” contains data from August 1999 to January 2001; “Post” includes data from July 2001 to May 2005. The red line indicates the geometric mean above which the beneficial use is not achieved. There were significant reductions in mean levels of both *E. coli* and *Enterococcus* bacteria.

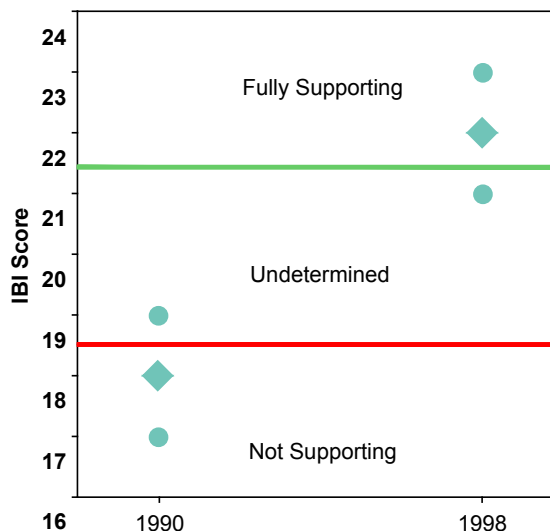
**Lake Creek Fish Bioassessment**

Fish bioassessment results from 1990 and 1998. Circles represent the IBI scores of fish collections at two sites in Lake Creek; diamonds indicate the average IBI score of the two sites. The improvement in these parameters resulted in an average IBI score that justified delisting (Oklahoma biocriteria allows pooling of data from multiple sites when they lie within the same reach).

median number of fish caught in 1998 was 637, compared to 299 in 1990. The increase in these parameters improved the IBI scores for Lake Creek to the degree necessary to fulfill the state biological criteria in support of the FWP beneficial use. Additionally, samples of Lake Creek water and sediment failed to exhibit any toxicity using the same tests that had demonstrated toxicity in 1990. Because of these results, Oklahoma removed Lake Creek from the 303(d) list for unknown toxicity and pesticides in 2002.

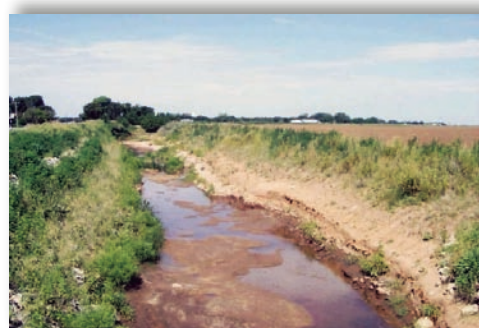
Potential sources of sediment and nutrients in the Salt Fork watershed before implementing the BMPs: fields were often cultivated or grazed to the edge of the stream; riparian buffers were nonexistent or rare.

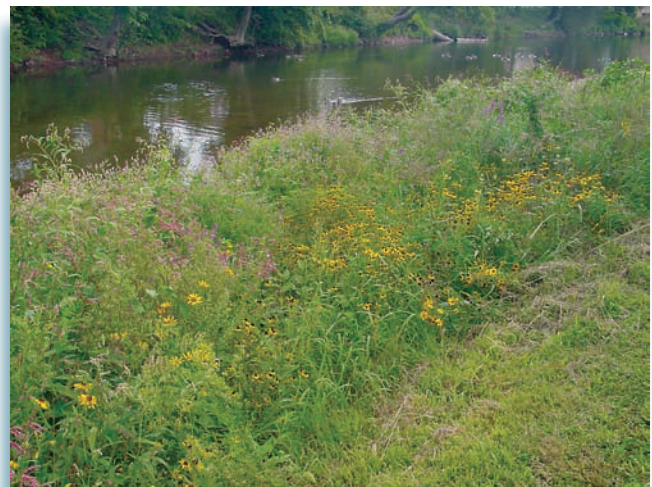
Restored riparian buffer along Manatawny Creek.

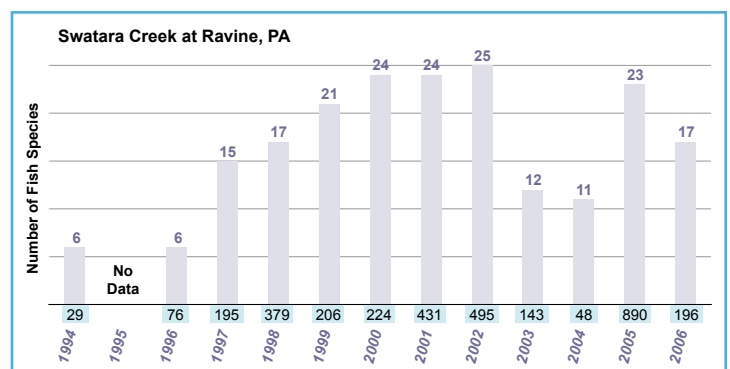
Low numbers of fish (species numbers are above the bar graph, individuals numbers are along the x-axis) in 2003 and 2004 are believed to be due to high water that made for difficult sampling conditions. In 2005 and 2006, with normal flow conditions, the fish population continued to grow.

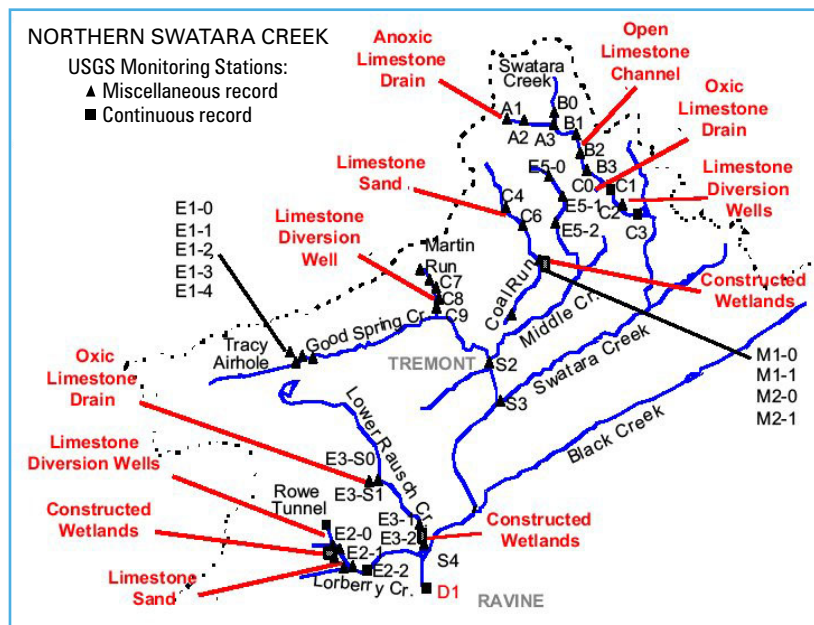
**Figure 2. Northern Swatara watershed and location of BMPs constructed to treat AMD**

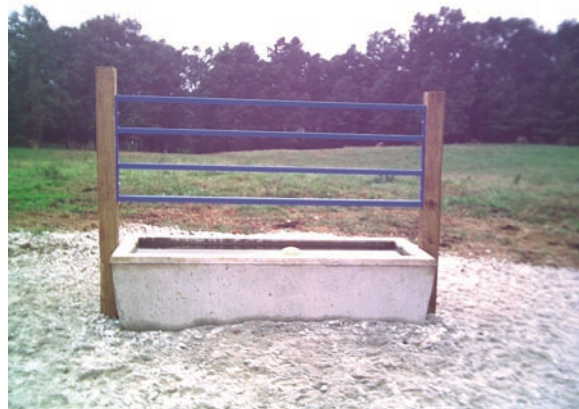
This alternative watering source on the Hendrix Farm keeps cattle out of nearby creeks and ponds.
